# Review of geological and seismotectonic investigations related to 1998 $M_w$ 5.6 and 2004 $M_w$ 5.2 earthquakes in Krn Mountains

Andrej GOSAR<sup>1,2</sup>

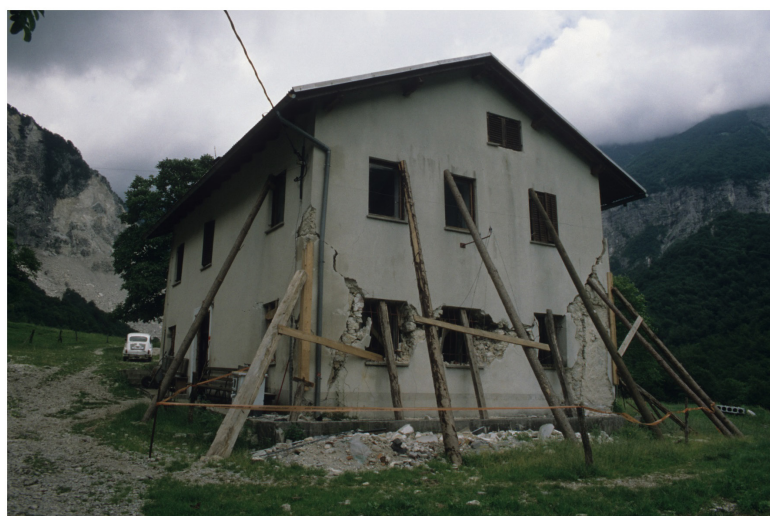
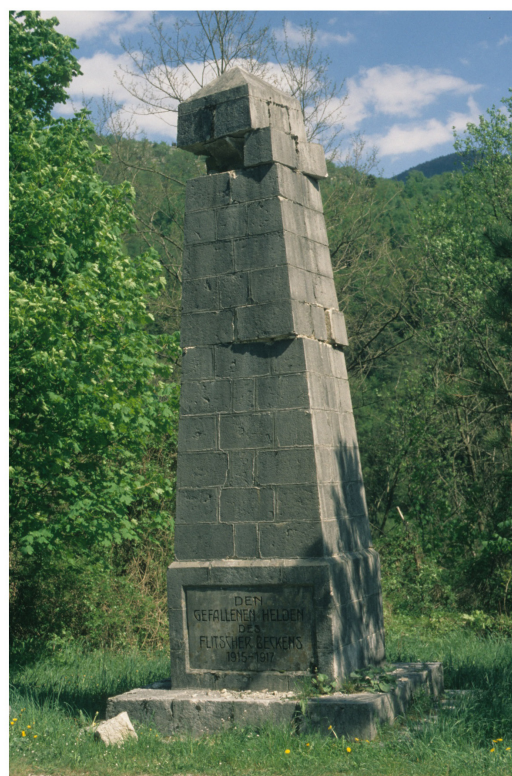
Fig. 1. In 1998 earthquake mainly older buildings, built of rubble and simple stone, were damaged (left), but also several monuments (right) (photo: A. Gosar).

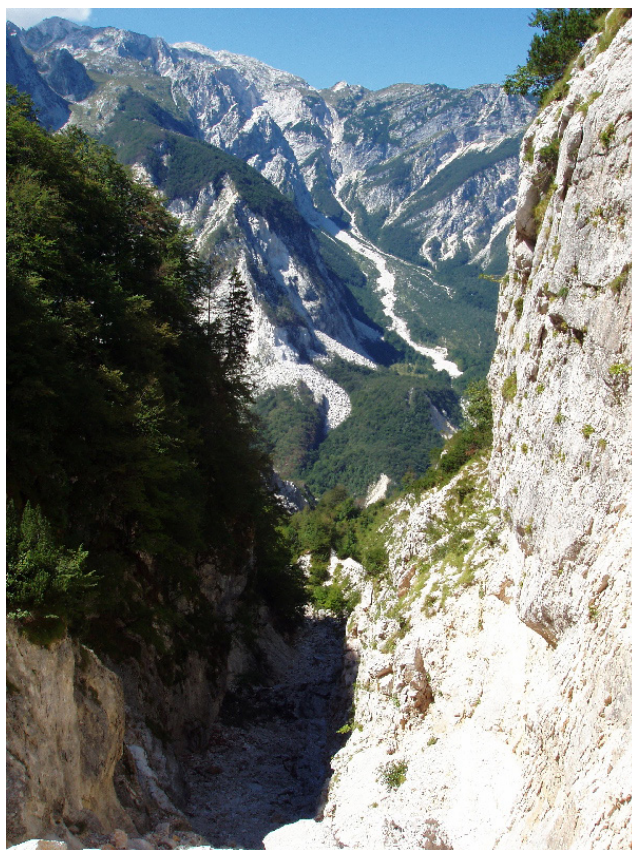
Fig. 2. The view of seismogenic Ravne fault across Tolminka spring basin towards NW (photo: A. Gosar).

The first seismotectonic analysis of the 1998 earthquake has shown that it occurred on a dextral strike-slip subvertical Ravne fault (figs. 2 and 3) oriented in NW-SE direction (Zupančič et al., 2001). This was the first case in Slovenia that a strong earthquake was undoubtedly related to a particular fault mapped in the field. Earlier, such seismotectonic relations were mainly precluded by large errors in earthquake foci locations due to very sparse distribution of seismological stations. The hypocentral depth of the 1998 event was 7.6 km. No surface rupture was found and based on distribution of aftershocks the fault rupture dimensions were assessed on 10 km  $\times$  7 km. The seismotectonic analysis was based on focal mechanisms, field observations and ortho photo aerial images. It was revealed that recent seismic activity in NW Slovenia is related to strike-slip Dinaric faults (fig. 3) as well as to thrusting along Southalpine thrust front and parallel planes (Zupančič et al., 2001). The area is located at the kinematic transition between E-W striking thrust faults of the Alpine system in Friuli and NW-SE striking dextral

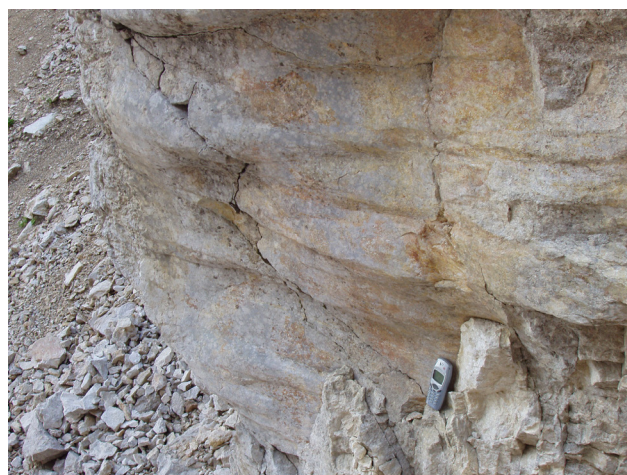
Fig. 3. Detailed view of the Ravne fault plane in a gully above Planina na Polju with clear indications of strike-slip character of this fault (photo: A. Gosar).

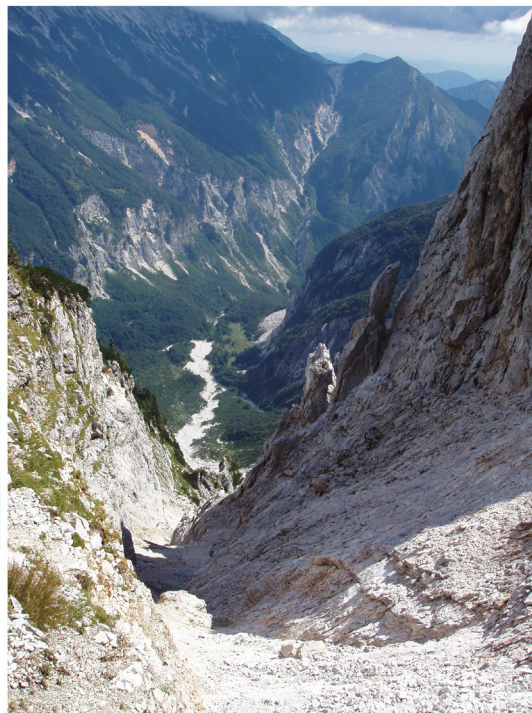
Fig. 4. 3D view of a Digital Elevation Model of the Ravne fault and Tolminka spring basin towards SE derived from LiDAR survey (left) and photo of the same area (right) (photo: A. Gosar).

In 2005, when airborne laser scanning (LiDAR) was still very rare and expensive (Gosar, 2007), we had, through international cooperation, an unique opportunity to survey Idrija and Ravne faults with this very promising method (Cunningham et al., 2007), which after a decade strongly changed the science of tectonic geomorphology, through providing high resolution bare earth digital elevation models. Measurements were very successful especially on the Idrija fault where details of near fault structures and Quaternary terraces were revealed. Based on this study a location in Kanomljica valley was proposed for later paleoseismological studies. On the Ravne fault the most interesting results were obtained in the Tolminka spring basin (fig. 4), where LiDAR images revealed several branches of the fault. It was interpreted as active transtensional basin within overall transpressional regime (Cunningham et al., 2006). This investigation represents the first application of airborne LiDAR in Europe for the purpose of mapping the surface expression of seismogenic faults.

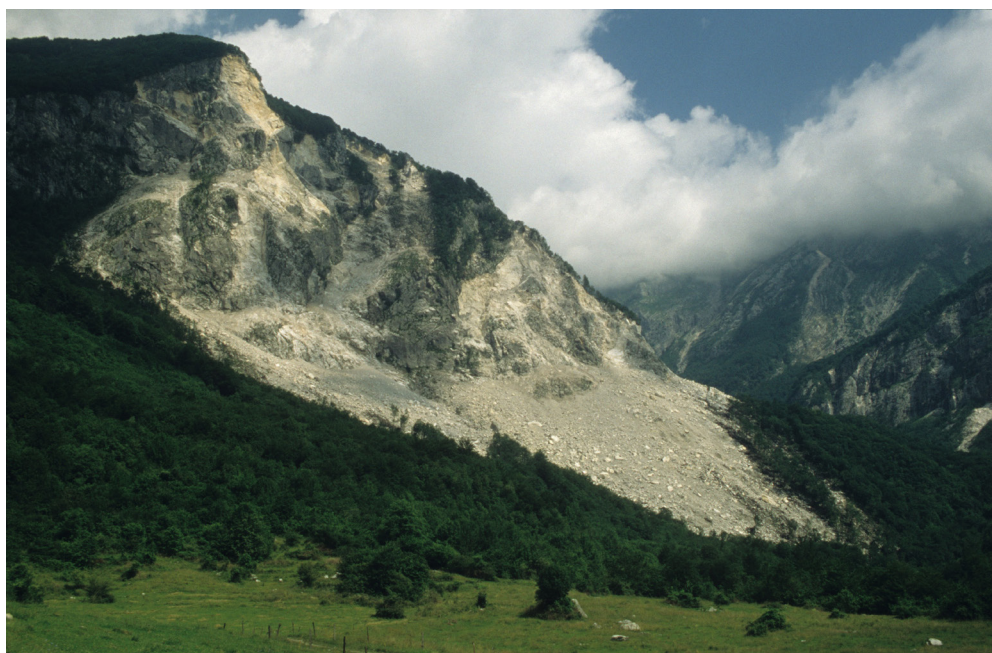
Fig. 5. Very large rockfall caused by the 1998 earthquake in which the whole SE face of the Osojnica Mountain above Tolminka valley collapsed (photo: A. Gosar in May 1998).

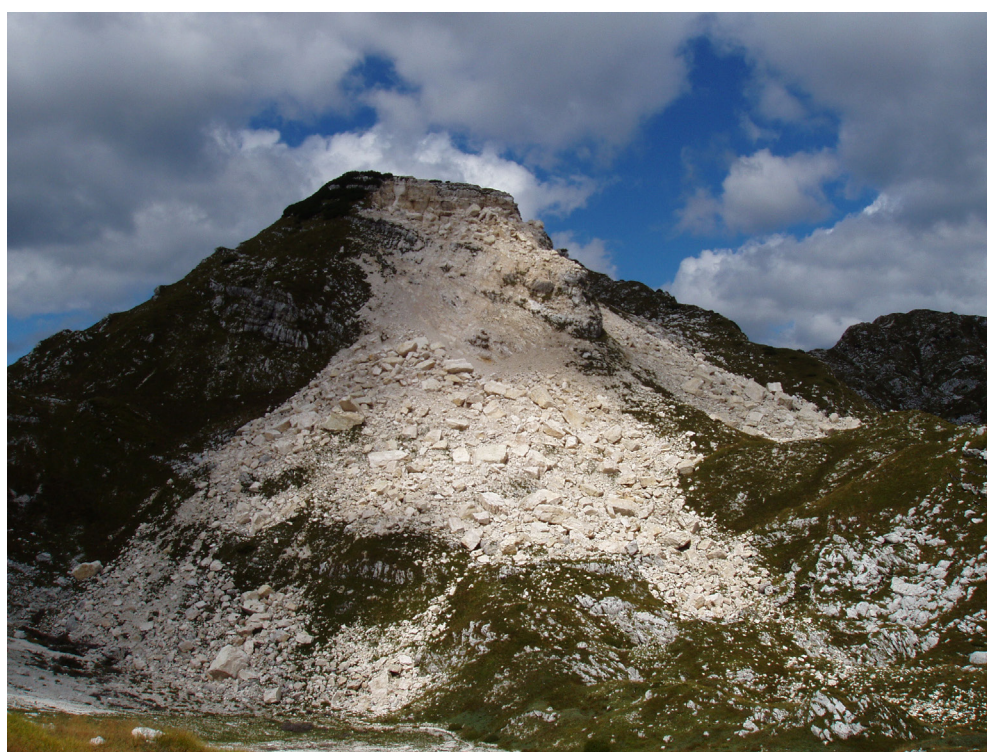
Fig. 7. A typical example of medium size rockfall occurred at V. Šmohor in Krn Mountains. The top of not very steep mountain collapsed (photo: A. Gosar in August 2003).

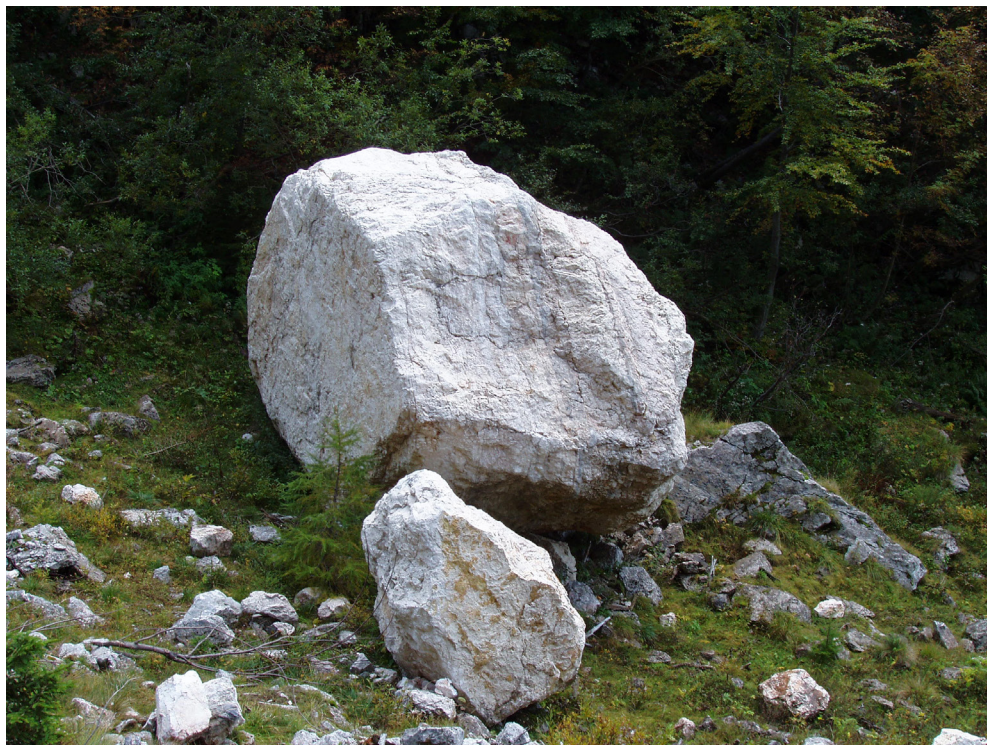
Fig. 8. A huge boulder in Dolič valley, very close to the epicentre of the 1998 earthquake, resulted from the rockfall on the Lipnik Mountain. The height of the boulder is 5 m (photo: A. Gosar in September 2004).

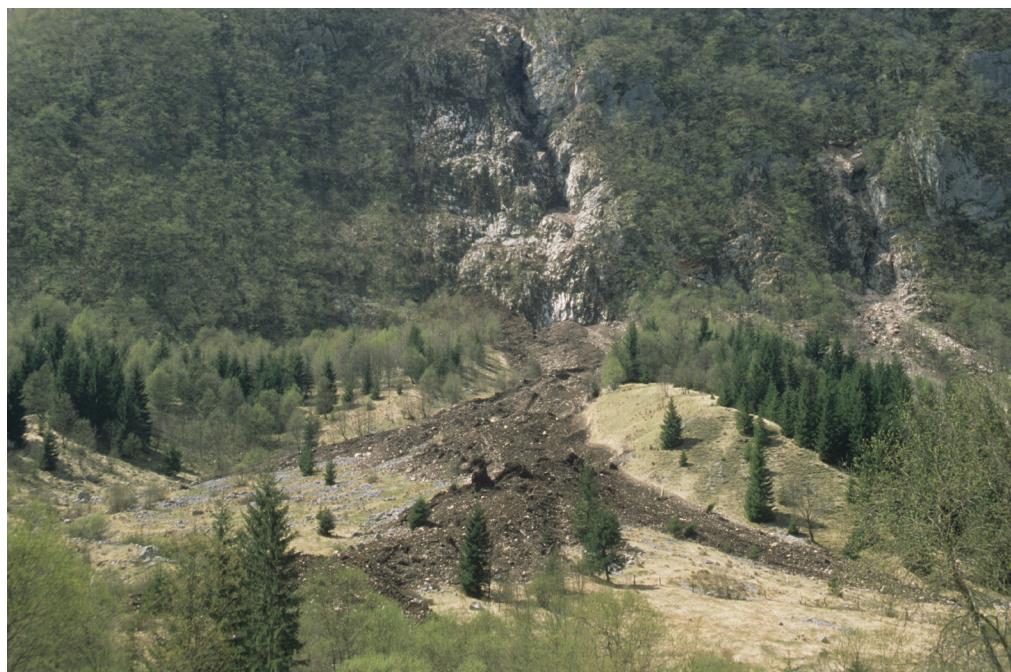
Fig. 9. Triggered by the 1998 earthquake, a mixture of snow, soil and rocks slid down a steep ravine in Lepena valley as an avalanche and created a fan shaped debris flow in the valley floor (photo: A. Gosar in May 1998).

Since at the time of the 1998 earthquake there was a large amount of fresh snow (more than 0.5 m) in Krn Mountains, some interesting phenomena, which can be classified in-between snow avalanche, landslide and debris flow occurred. The most characteristically one occurred in Lepena valley (fig. 9). A mixture of snow, soil and rock slid down a steep ravine as an avalanche for

more than 500 m of elevation difference. When it reached the valley floor, the debris was deposited as a debris flow in a wide fan (Vidrih & Ribičič, 1999; Gosar, 2012).

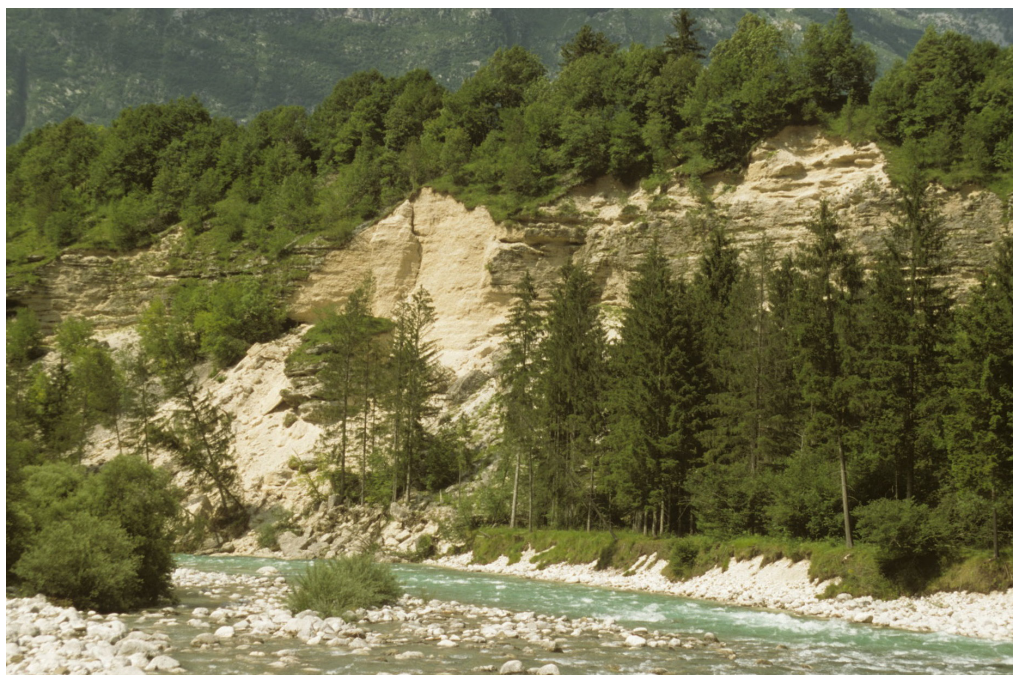
Fig. 10. Heterogeneous glacial and fluvial sediments in the Bovec basin were responsible for large variations in seismological site effects and consequently to the degree of buildings damage. A rockfall occurred in the wall above the Soča river during the 1998 earthquake (photo: A. Gosar in May 1998).

groups. At that time a new seismic hazard map showing ground acceleration for Slovenia was not yet available. Therefore, the seismic microzonation map was prepared to be used with the old seismic hazard map showing expected intensities for a return period of 500 years. According to this map NW Slovenia was characterized by expected intensities of VIII and IX on MSK scale and seismic microzonation provides intensity increments. For a Bovec basin a more detailed geotechnical map was prepared in which rocks and sediments were classified in eight types. Based on it, a detailed seismic microzonation of the Bovec basin was prepared, which shows that most of the area is characterised by  $VIII_2$  and  $VIII_3$  intensities (Ribičič et al., 2000; Ribičič, 2011). Considering also resonance effects between sediments and structures, preliminary microtremor method investigations were carried out in affected area to explain large variations in damage to buildings due to site effects (Gosar, 1999a; Gosar, 1999c). It turned out that resonance effect could play important role in distribution of damage especially in the Bovec basin filled with heterogeneous sediments (fig. 10).

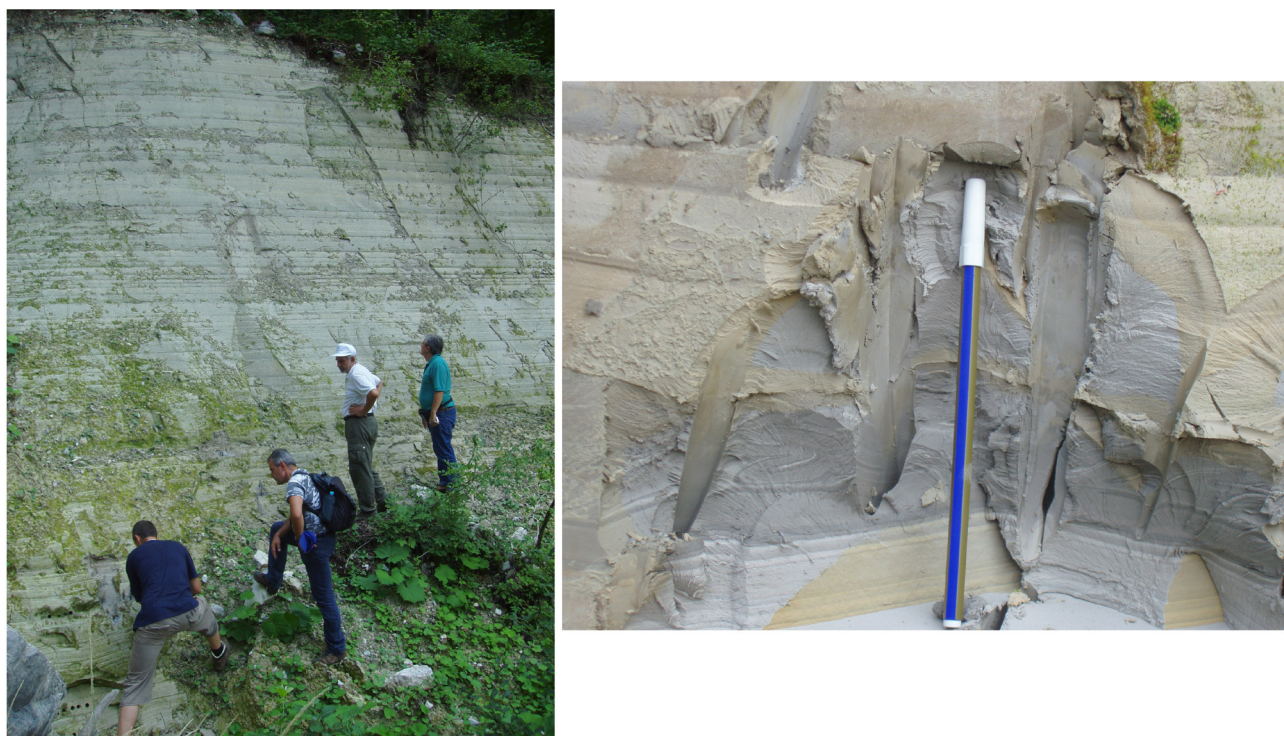
Fig. 11. Soft lacustrine sediments as exposed in abandoned clay pit near Srpenica can significantly amplify seismic ground motion and are classified as ground type E according to the Eurocode 8 standard. a) General view of thin bedded lacustrine deposits, b) close view of very soft sediment (photo: A. Gosar).

ing to Eurocode 8 was as follows. Solid rocks as carbonates, marlstone, sandstone, breccia, flysch rocks and shale represents ground type A. Alluvium of Lepenjica river represents ground type B, older Quaternary sediments ground type C and younger Quaternary sediments and fluvial sediments of Bovec basin ground type D. Ground type E is represented by fine grained river sediments, diamicts overlying ground type A, lacustrine chalk (fig. 11) and alluvium near Kobarid (Trobec, 2012). By application of soil factors the maximum design ground acceleration for a return period of 475 years in the area is 0.425 g on ground type E (soil factor 1.7, design ground acceleration on rock 0.250) in Breginjski kot, which is close to the highest values assessed in Slovenia. This value is surpassed only in the Ljubljana Moor where on very soft lacustrine and marsh sediments (ground type  $S_1$ ) the design ground acceleration on solid rock of 0.250 g can be increased in the northern part by soil factor of 2.55 on 0.635 g and in other parts the design ground acceleration on solid rock of 0.225 g can be increased on 0.575 g (Zupančič et al., 2004).
