Engineering-geological conditions of landslides above the settlement of Koroška Bela (NW Slovenia)

Tina PETERNEL, Jernej JEŽ, Blaž MILANIČ, Anže MARKELJ & Mateja JEMEC AUFLIČ

Geološki zavod Slovenije, Dimičeva ulica 14, SI-1000 Ljubljana, Slovenija; e-mails: tina.peternel@geo-zs.si, jernej.jez@geo-zs.si, blaz.milanic@geo-zs.si, anze.markelj@geo-zs.si, mateja.jemec-auflic@geo-zs.si

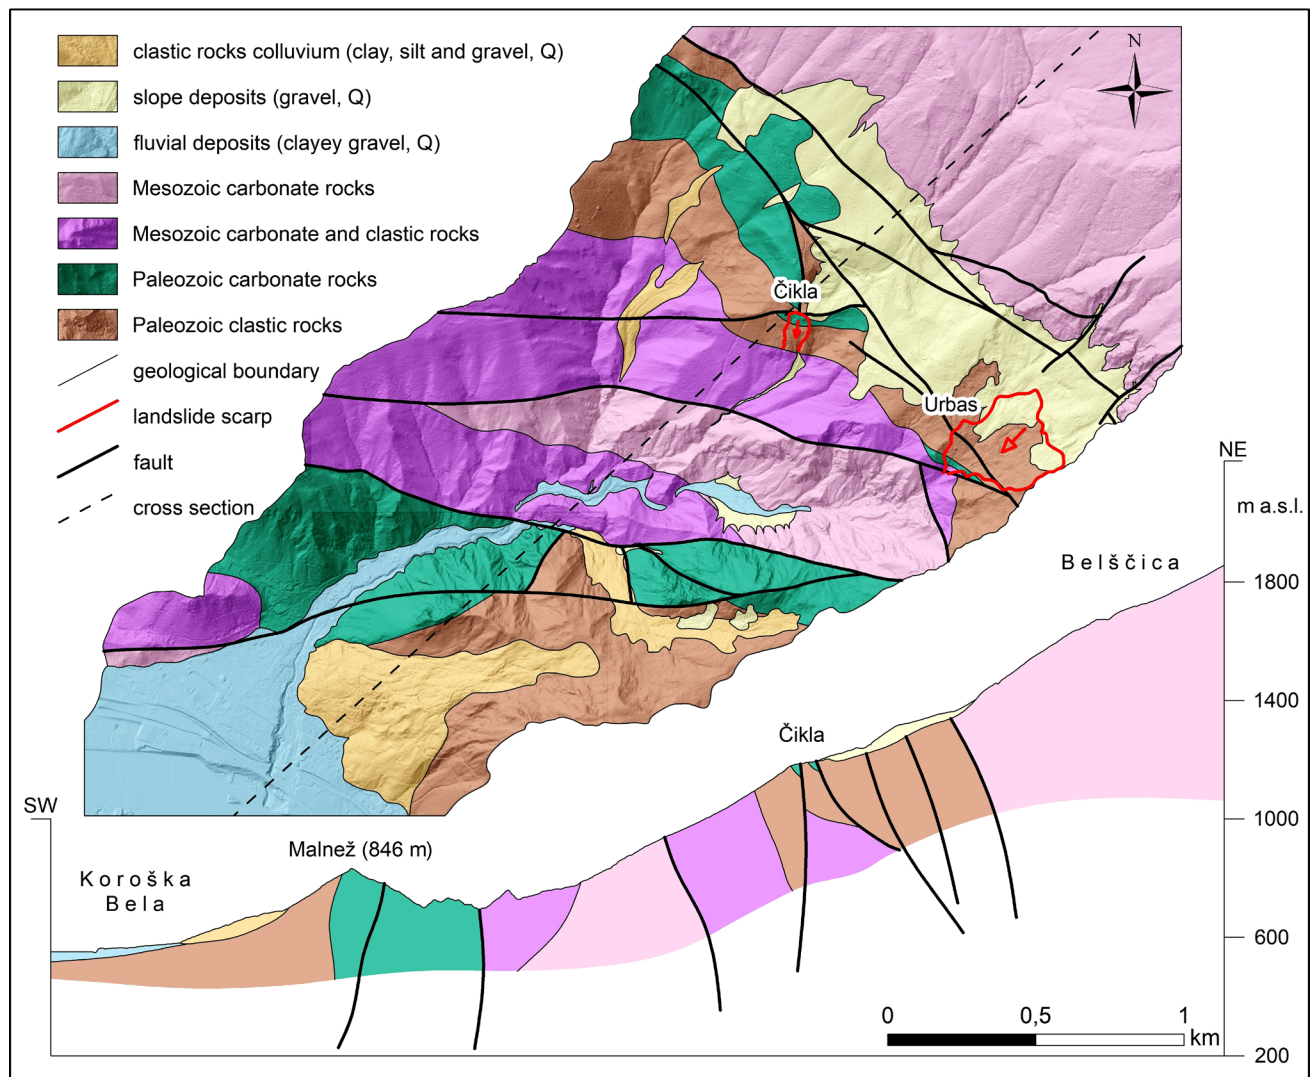
Fig. 1. Geological map and cross section of the hinterland of Koroška Bela.

The broad area of the hinterland of Koroška Bela exhibits fairly complex geological and tectonic conditions (fig. 1). Geological units of the study site are mainly represented by Upper Carboniferous and Permian sedimentary clastic rocks – Permian carbonates and Triassic to Lower Jurassic carbonate rocks (Jež et al. 2008). The main slope instabilities are related to tectonic contacts between the Upper Carboniferous to

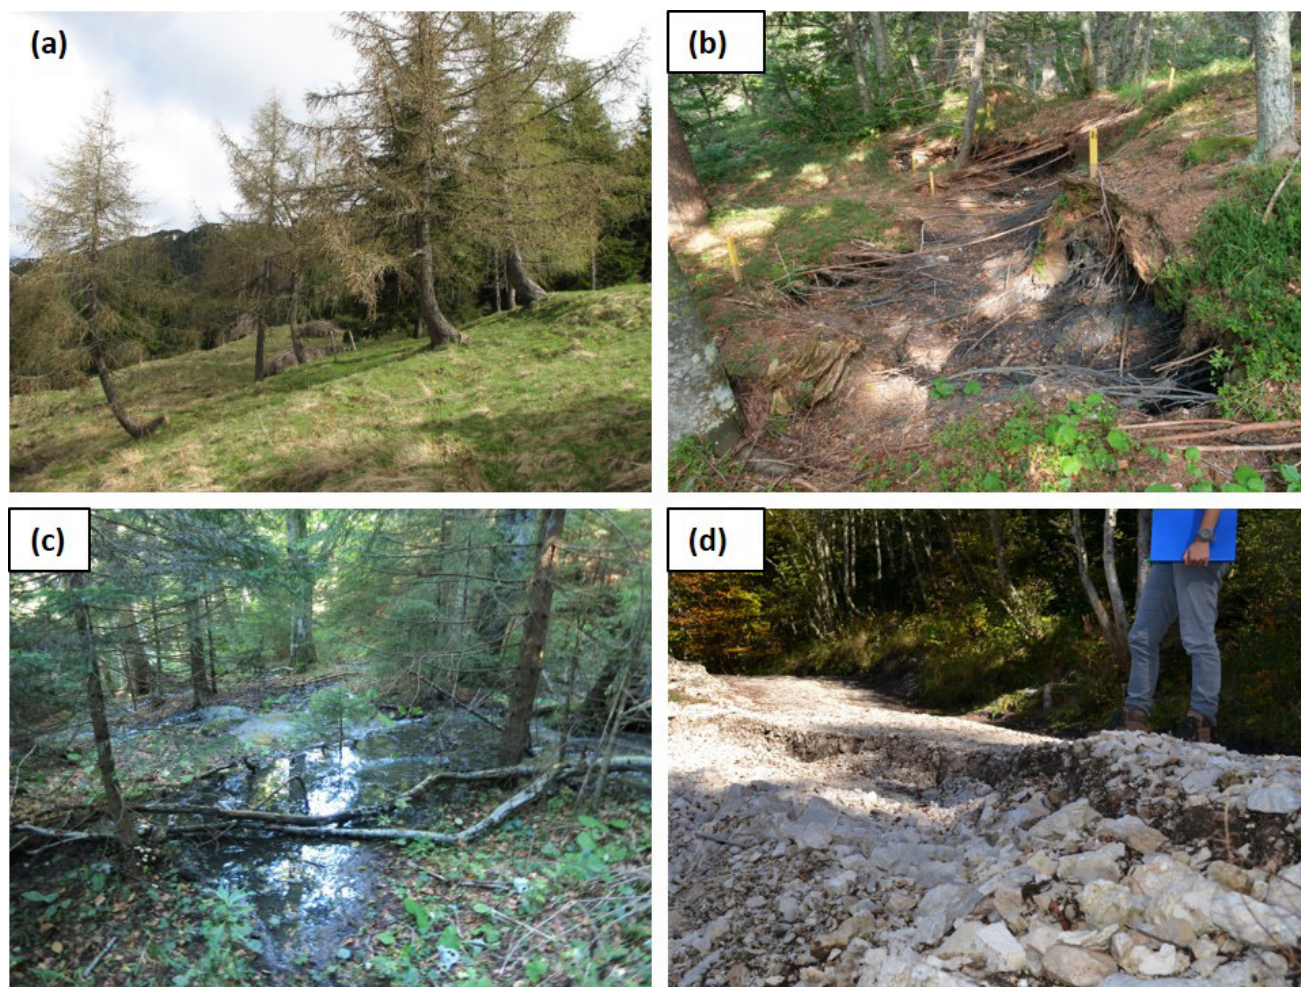
Fig. 2. Failure features on the surface: (a) Hummocky terrain with curved trees (b) Longitudinal tension cracks (c) Ponds on the surface (d) Subsidence of road

The morphology of the entire hinterland of Koroška Bela is characterized by irregular and hummocky terrain comprised of protrusions and depressions of various sizes. Such activity is evidenced by “pistol butt” trees (fig. 2a), longitudinal tension cracks (fig. 2b), erosion slumps and ponds on the surface (fig. 2c), as well as the common deformation of local roads (fig. 2d).

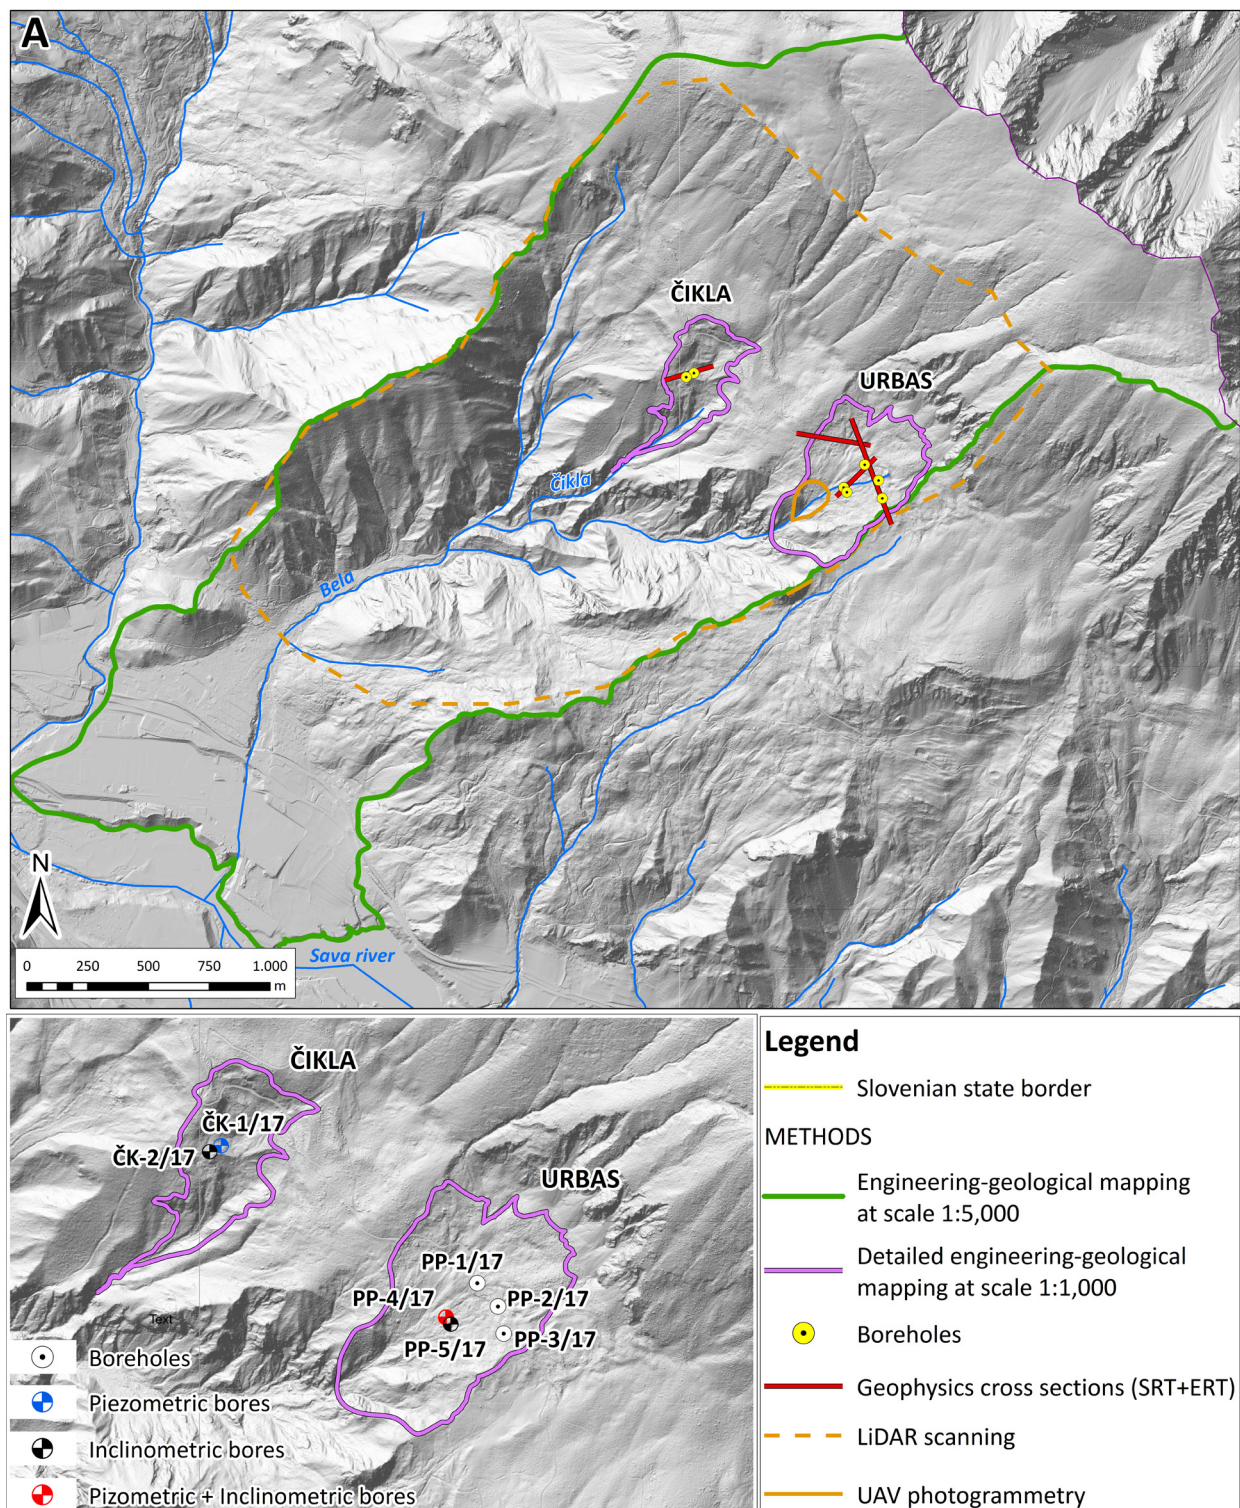
Fig. 3. Spatial distribution of applied methods (Peternel et al., 2017a).

The Koroška Bela hinterland has been investigated by combining detailed engineering-geological mapping, geotechnical, geophysical and geodetic methods. This paper reports the results of engineering-geological mapping and geotechnical monitoring using inclinometer measurements. Hydrogeological investigations are represented in Janža et al., 2018. The spatial distribution of all applied methods is shown in fig. 3.

An important part of the investigation of the Urbas and Čikla landslides involved the core drilling and core logging of 7 boreholes that was undertaken in September 2017. The locations for the boreholes were determined based on a field survey and logistical factors (accessibility of area) (fig. 3).

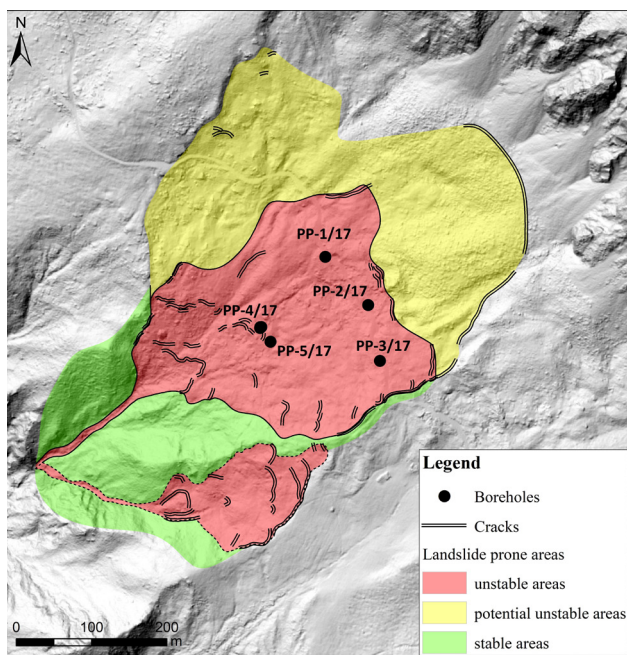
Fig. 4. Map of Urbas landslide-prone areas with contribution landslide.

As a result, the Urbas and Čikla landslides were divided according to landslide prone areas (figs. 4, 5):

The active part of the Urbas landslide (fig. 4) extends over an area measuring some 320×420 m and covers an area of approximately $85,320 \text{ m}^2$. The entire landslide including potentially unstable areas measures up to 460×560 m.

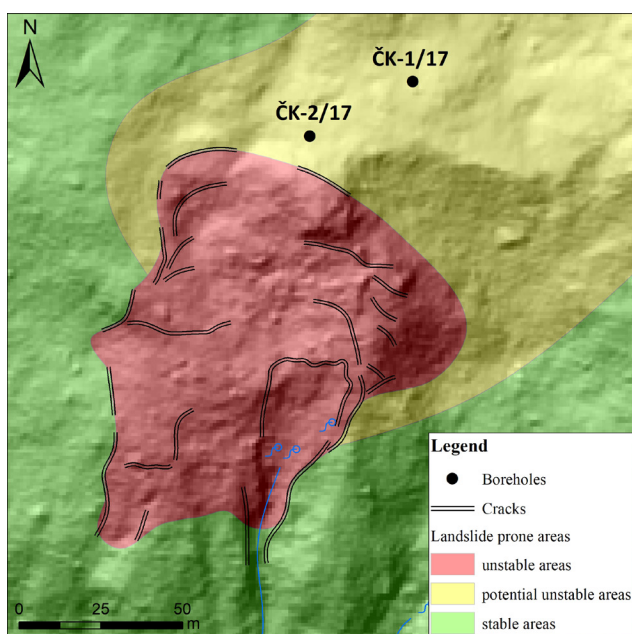
Fig. 5. Map of Čikla landslide-prone areas.

In the case of the Čikla landslide (fig. 5), the active area covers an area of 105×130 m, and is actively progressing toward NE, with a surface area extending over an area of approximately $8,000 \text{ m}^2$.

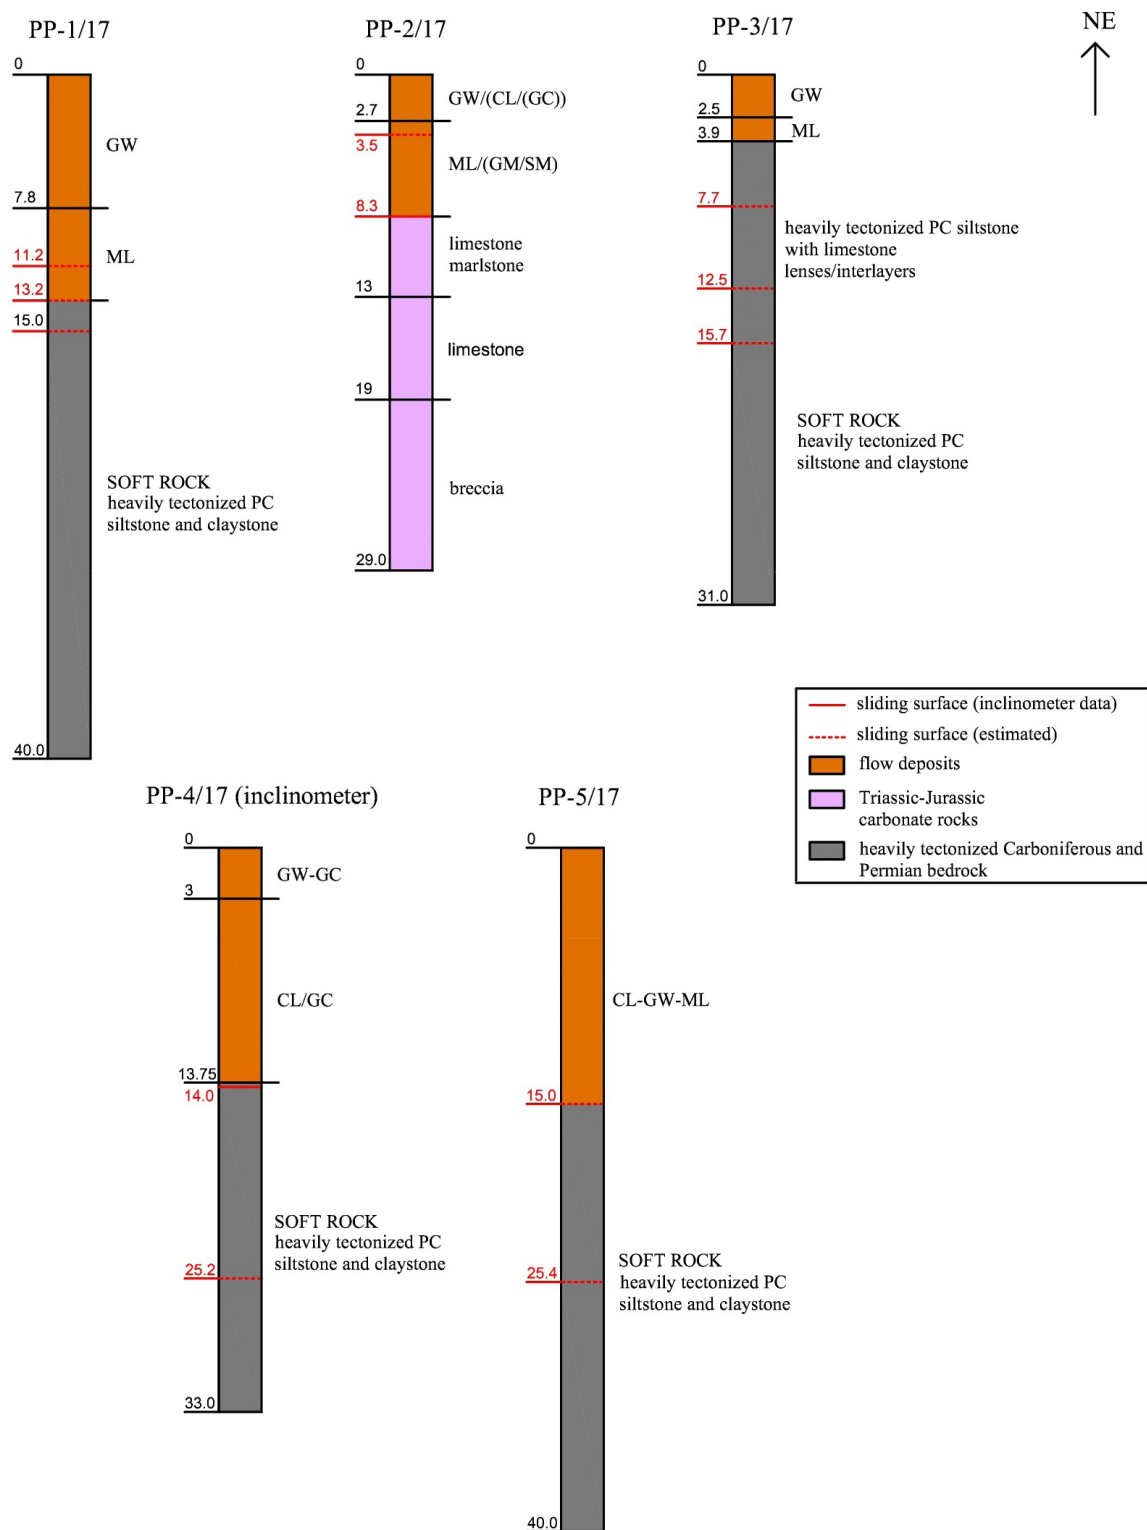
Fig. 6. Geotechnical borehole logs of the Urbas landslide. The locations of the boreholes are shown in fig. 3.

The results of the core logging for the Urbas landslide are shown in figure 6.

In borehole PP-1/17 a core was drilled up to 40.0 m. According to the detailed core logging of PP- 1/17 three main lithological units were recognized. The uppermost layer (0–7.8 m) is represented by Quaternary Unit (Q) debris deposits that are composed of scree material (GW) and scree material with clayey or/and silty binder (GC/GM). A lower depth (7.8–13.2 m), the silty and clay debris (ML, CL) prevail over talus debris. At a depth of 13.2 m the bedrock appears as grey, heavily deformed Upper Carboniferous and Permian clastic rock. Three slip surfaces are presented in boreholes PP-1/17 at depths of 11.2, 13.2 and 15.0 m. The determined slip surfaces are related to wet segments, to contacts between soil and soft rock, and to a segment inside highly tectonized PC-siltstone.

In borehole PP-2/17, the core was drilled down to 29.0 m. The upper layer (0–2.7 m) of PP-2/17 is represented by scree material containing silt and clay particles (GW/(CL)/(GC)). This layer gradually becomes a silt section with individual layers of silty gravel and silty sand (2.7–8.3 m). At a depth of 8.3 m, the section of grey, heavily-deformed Upper Carboniferous and Permian carbonate and clastic rock appears. Between 8.3 and 13.0 m the section is represented by limestone, sandstone and sandy marlstone. Further down (13.0–19.0 m) PP-2/17 is represented by a section of limestone that at a depth of 19 m becomes limestone breccia. In borehole PP-2/17 two slip surfaces were recognized at depths of 3.5 and 8.3 m. The first is related to a wet core segment, while the second represent the contact between soil and soft rock immediately above the bedrock.

In the third borehole of PP-3/17, the total length of the core is 31.0 m. In the upper part it starts with a 3.9 m layer of Quaternary Unit (Q) debris deposits (GW). At a depth of 3.9 m the grey, completely weathered Upper Carboniferous and Permian clastic rock appears. From engineering-geological point of view this layer can be

In borehole PP-4/17, the core was drilled down to 33.0 m and was equipped with an inclinometer. The uppermost layer (0–3.80 m) is represented by Quaternary Unit (Q) debris deposits that are composed of scree material (GW) and scree material with clay matrix. From 3.8 to 13.75 m

the carbonate scree is mixed with clay debris (CL). At a depth of 13.75 m the bedrock appears as grey, heavily-deformed Upper Carboniferous and Permian clastic rock. In borehole PP-4/17 two slip surfaces were recognized at depths of 14.0 and 25.2 m. The first was recognized based on inclinometer measurements, while the second is related to a segment inside well-weathered PC-siltstone and a wet zone.

In the fifth borehole of PP-5/17, the core was drilled to 40.0 m. The upper layer (0–16.0 m) of PP-5/17 is represented by alternating scree material (GW), scree material with silty binder (GM) and sand (SM), clay (CL) or silty (ML) debris. The bedrock appears at a depth of 16.0 m as a grey, heavily-deformed Upper Carboniferous and Permian clastic rock. Two slip surfaces are presented in PP-5/17 at depths of 15.0 and 25.4 m. The determined slip surfaces are related to wet segments, to contacts between soil and soft rock, and to a segment inside highly-weathered PC-siltstone.

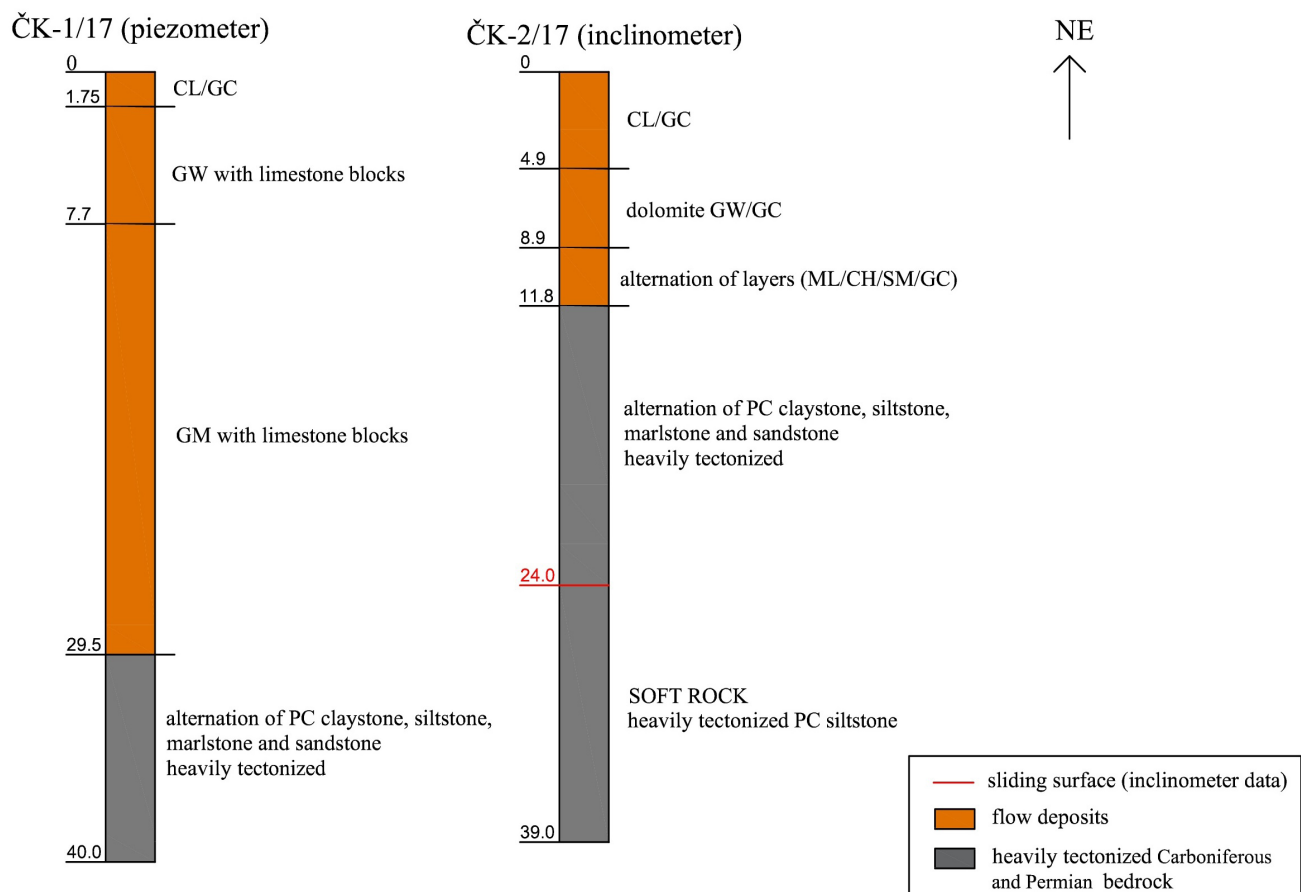
Fig. 7. Geotechnical borehole logs of the Čikla landslide. The locations of the boreholes are shown in fig. 3.

equipped with an inclinometer. Both boreholes were drilled in area that was considered as potentially unstable areas in the immediate hinterland of the currently active landslide (fig. 5). The results of core logging for the Čikla landslide are shown in figure 7.

In borehole ČK-1/17, the core was drilled down to 40.0 m and was equipped with a piezometer. Hydraulic conductivity of borehole sections and groundwater level fluctuations in ČK-1/17 are presented in Janža et al., 2018. According to detailed core logging of ČK-1/17, three main lithological units were recognized. The uppermost layer (0–29.5 m) is represented by Quaternary Unit (Q) debris deposits that are the consequence of fossil alluvial events. Deposits are composed of scree material (GW) with limestone blocks and scree material with silty binder. At a depth of 29.5 m the residual soil is composed of completely tectonized and weathered Upper Carboniferous and Lower Permian siltstone, with lenses of marlstone that gradually transit into massive siltstone.

In the second borehole of ČK-2/17, the total length of the core is 39.0 m. The uppermost layer (0–4.9 m) some 4.9 m thick is composed of silty

clay (CL) and clayey gravel (GC) with a transition into silty sand (SM) and clay (CH). At a depth of 4.9 m to 8.9 m a layer of dolomite gravel and gravel with clay matrix appears, followed by a section (8.9–11.8 m) of alternating layers (ML, CH, SM, GC). At a depth of 11.8 m a section (11.8–24.0 m) of completely tectonized and weathered Upper Carboniferous and Permian clastic rock appears. This layer is composed of alternation of gravel and clayey gravel with alternating layers (SM, CH, ML) followed by silty sand with gravel. At a depth of 24.0 m a grey, completely deformed Upper Carboniferous and Lower Permian siltstone appears. Due to drilling, primary sedimentary structures of the rocks are largely unrecognizable in the core.

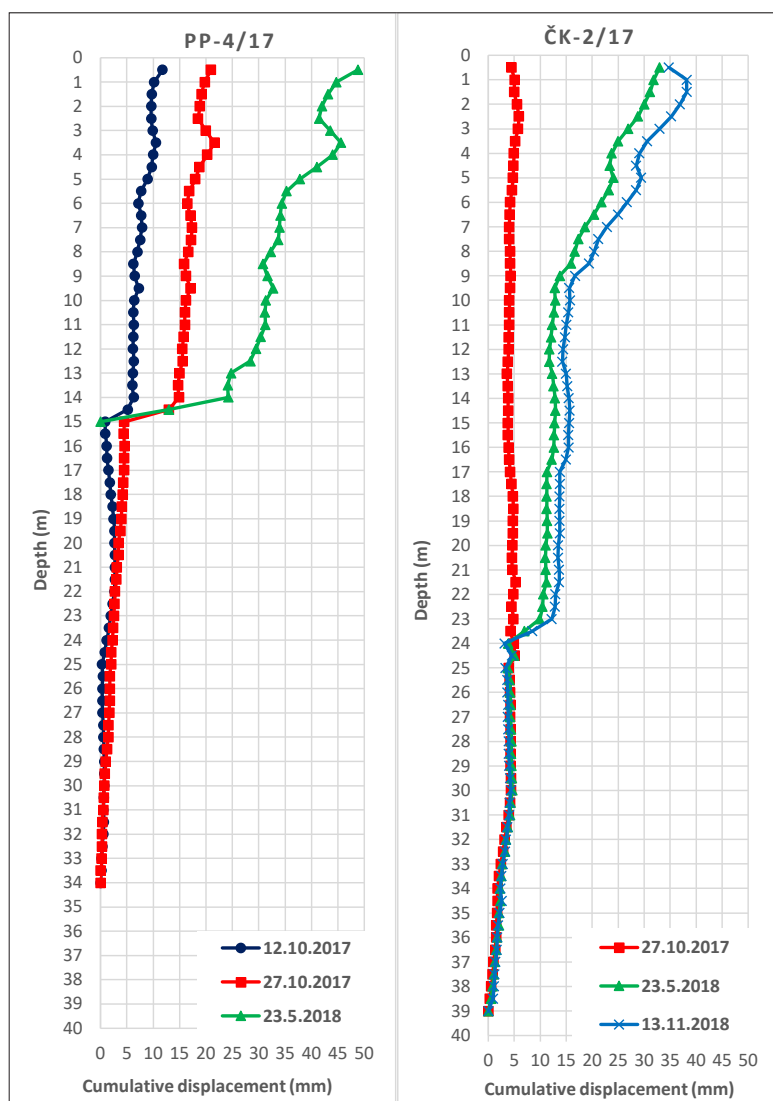
Fig. 8. Displacement measured by the inclinometers installed at PP-4/17 (Urbas landslide) and ČK-2/17 (Čikla landslide).

The main purpose of employing inclinometer measurements was to determine absolute and displacement rates. The results are presented as displacement profiles (fig. 8), which are used to determine magnitude, depth, direction and rate of ground movement.

The displacement vertical profiles of the 2 inclinometer measurements at PP-4/17 and ČK-2/17 are shown in figure 8. The inclinometer installed in borehole PP-4/17 shows cumulative absolute displacements in the slope face direction of some 24 mm between October 2017 and May 2018 down to a depth of 14 m. Based on core logging the slip surface is related to heavily deformed Upper Carboniferous and Permian clastic rocks. The last measurement showed that the inclinometer installed in borehole PP-4/17 was cut at a depth of 14 m (fig. 8).

Although that borehole ČK-2/17 was located in the area that was considered as potential unstable area (approx. 15 m behind the crown crack of active landslide), inclinometer installed in borehole ČK-2/17 showed significant displacements at a depth of 24 m. The measurements detect absolute cumulative displacements near 12 m over a period of 1 year (fig. 8). As in PP-4/17, the slip surface is related to heavily deformed Upper Carboniferous and Permian clastic rocks.
