Reasons for Elevated Radon Levels Inside the Building in Divača

Petra ŽVAB¹, Janja VAUPOTIČ² & Tadej DOLENEC³

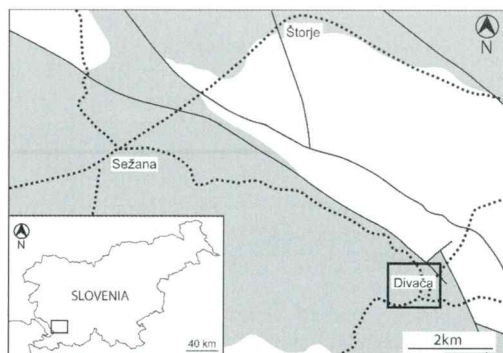
Figure 1. Location and simplified geological map of the south-eastern Karst (modified after Buser, 1968); Cretaceous carbonates are shaded in grey and Palaeogene beds in white, full line presents faults and dashed line main roads, investigated area is marked by rectangle.

The investigated area is part of the Karst and is located in the south-eastern part of the Trieste-Komen plateau, in Divača (Fig.1). Structurally, the area belongs to the External Dinarides (Placer, 1999) which are divided into more lower-order structural units. The northern, structurally highest, is Trnovo nappe and is underthrust towards the south by Hrušica nappe, Snežnik thrust sheet, Komen thrust sheet, Koper thrust fault and the Istrian autochthon (Placer, 1981). The Karst belongs to the Komen thrust sheet and, more precisely, to the Trieste-Komen anticlinorium.

The Trieste-Komen plateau is composed predominantly of Cretaceous beds which are in contact locally with the Palaeogene beds (Fig.1) (Buser, 1973; Pleničar, 1973; Jurkovšek et al., 1996). Sedimentary rocks of this area are predominantly carbonates and, rarely, clastites. In the southern part of the Trieste-Komen plateau, Cretaceous and Paleocene succession was divided into seven formations (Jurkovšek et al., 1996). In the Divača region the Cretaceous Sežana, Repen and Povir Formation were recognized and are separated from the Palaeocene Liburnian Formation by the Divača fault. Formations are characterized predominantly by limestone, and exhibit solution porosity, which is most intense in fissured zones.

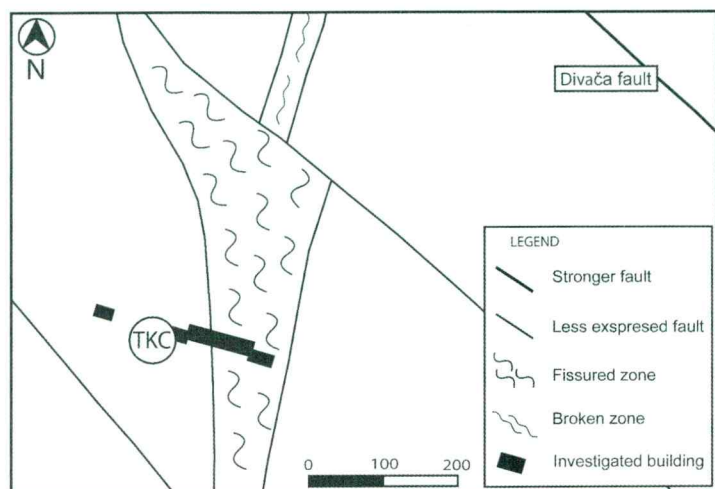
Figure 2. Structural map of the Divača site and position of the TKC room.

The Divača fault, as the main regional structure, is considered to be the predominant influence on the structural characteristics of the investigated area. From the structural mapping around Divača we defined two smaller scale NW-SE (dinaric) faults which are parallel and situated south-west of the Divača fault. Fissured zones exist in the north-south direction, between the dinaric faults, and are very probably the result of a local extensional tectonic regime. Fissured zones are considered to be potential migration routes of radon and the building with the highest radon levels is situated directly above one of them. A structural map of the site is shown in Fig. 2.

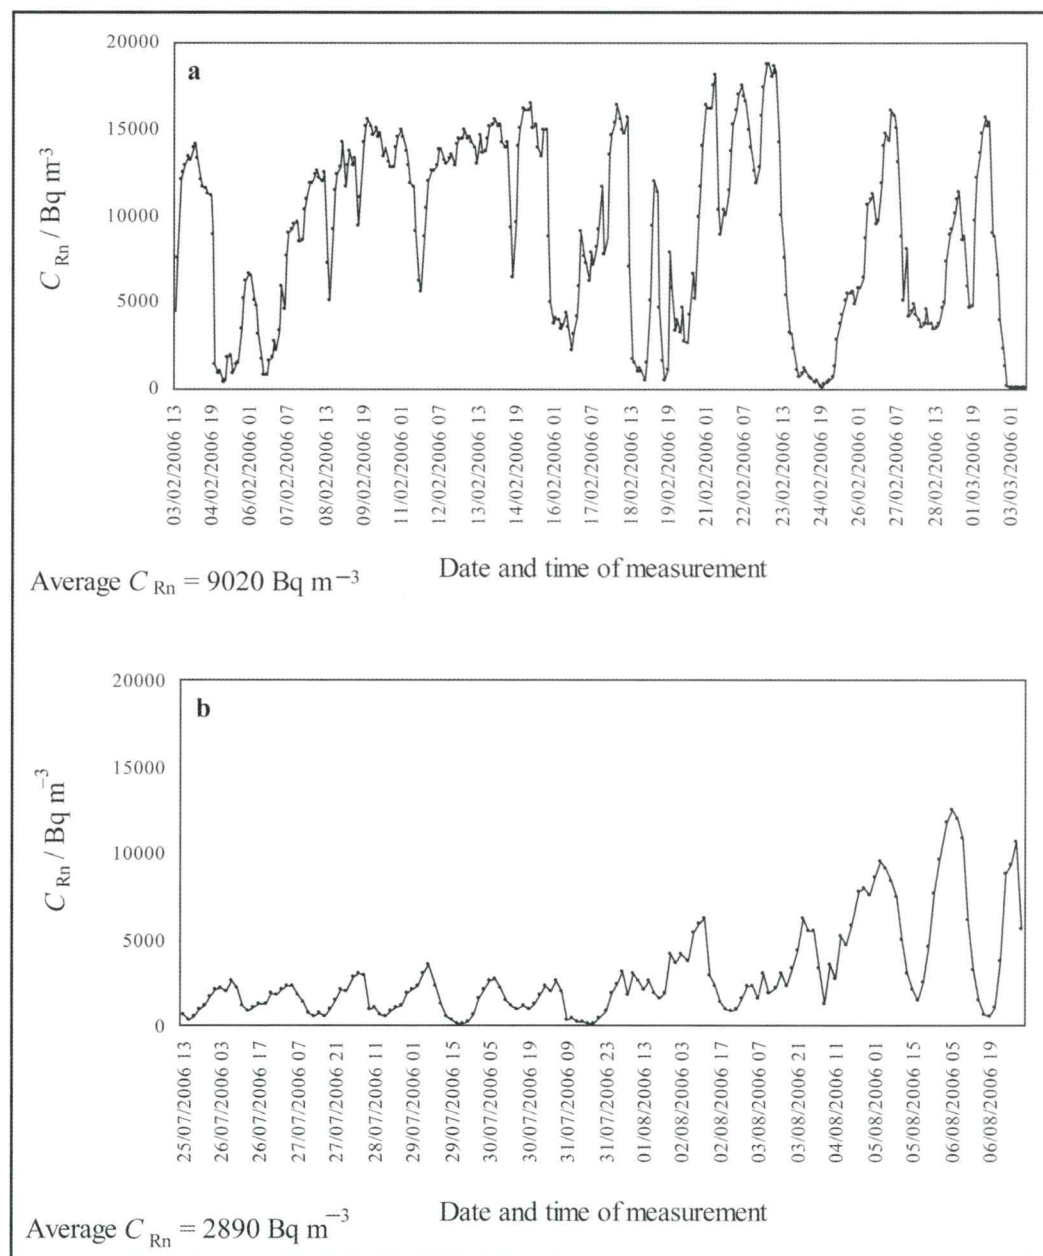
Figure 3. Time variation of indoor air radon concentration in the TKC room: a) in winter, from February 3 to March 3, and b) in summer, from July 25 to August 6.

Diurnal variations of indoor radon concentration in the TKC room in winter and summer 2006 are shown in Figs. 3a and 3b, respectively. It can be seen that instantaneous values can reach values as high as $10,000 \text{ Bq m}^{-3}$ and very rarely fall below the national limit of 1000 Bq m^{-3} (but neither of these during working hours), with average values of 9020 Bq m^{-3} and 2890 Bq m^{-3} , respectively. As expected (Vaupotič et al., 1998), concentrations in summer were lower than in winter. Because of occupation 7 days a week, no increase was observed during weekends (Vaupotič, 2002), i. e., February 4–5, February 11–12, February 18–19, February 25–26, July 29–30 and August 5–6.

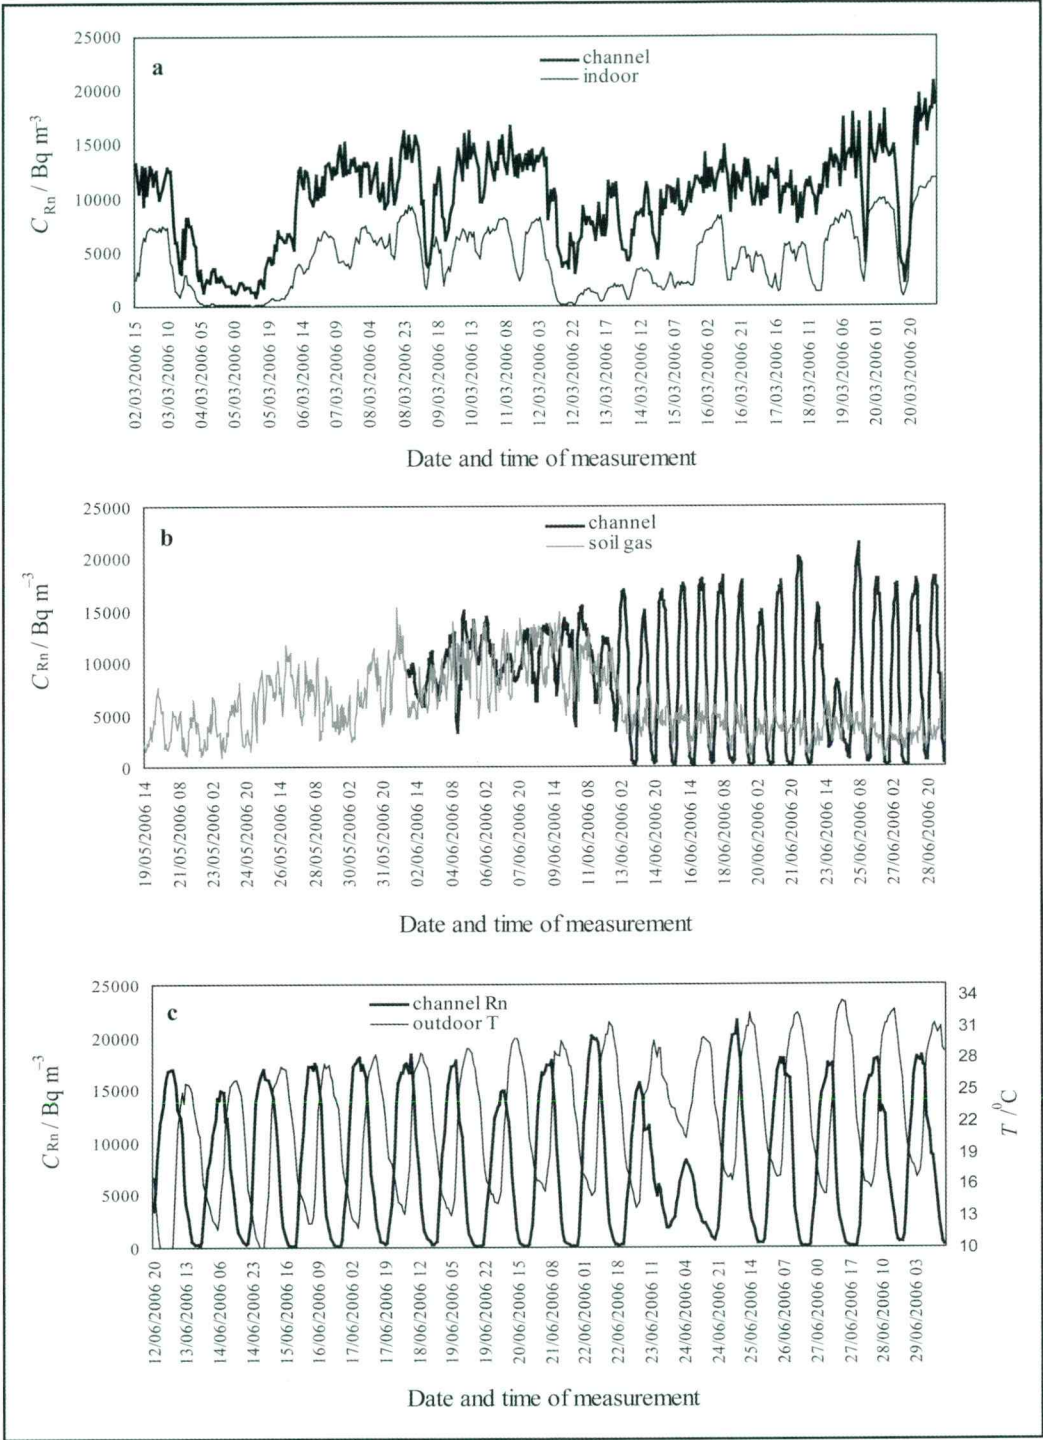
Figure 4. Relationships between a) radon concentration in indoor and channel air, b) radon concentration in the channel air and soil gas, and c) radon concentration in the channel air and outdoor air temperature.

Soon after the first inspection, the under-floor channel was suspected to be the main source of the high indoor radon concentration. This was confirmed by simultaneous radon monitoring in the room and channel. Radon levels in the channel were followed by radon levels in the room without measurable time delay (Fig. 4a). Radon concentration in the room was only three times lower than in the channel, demonstrating that the metal cover of the channel is a poor barrier for entry of radon into the room.

Fig. 4b compares radon concentrations in the channel air and in soil gas. In the period of June 2–12 the values are similar. After this, soil gas values decrease while the channel values increase, showing pronounced fluctuations between less than 100 Bq m^{-3} up to as high as $20,000 \text{ Bq m}^{-3}$. This may be explained by an increase in outdoor air temperature, which produces an increase in radon exhalation from the ground. This resulted in a lower soil gas concentration in the upper 60 cm layer and in enhanced radon accumulation in the channel. Fig. 4c shows that minima in radon concentration in the channel air coincide, with only a short time delay, with maxima in outdoor air temperature. When, on a sunny day, the outdoor air temperature reached 30°C , the temperature of the concrete slab above the channel in the courtyard reached even higher values. Because the indoor air temperature in the TKC room is kept below 25°C , this temperature difference causes a 'chimney effect' in the channel, producing a draught of air from the courtyard towards the room, thus sweeping radon-rich air from the channel into the TKC room and, further, into the outdoor

air. When the outdoor air temperature starts to decrease in the afternoon, the temperature difference in the channel steadily decreases, air draught is reduced and eventually stopped (or minimised), and radon starts to accumulate to reach its highest concentration during the night.
